Charter Township of Texas Flood Study

Texas Township Flood Mitigation

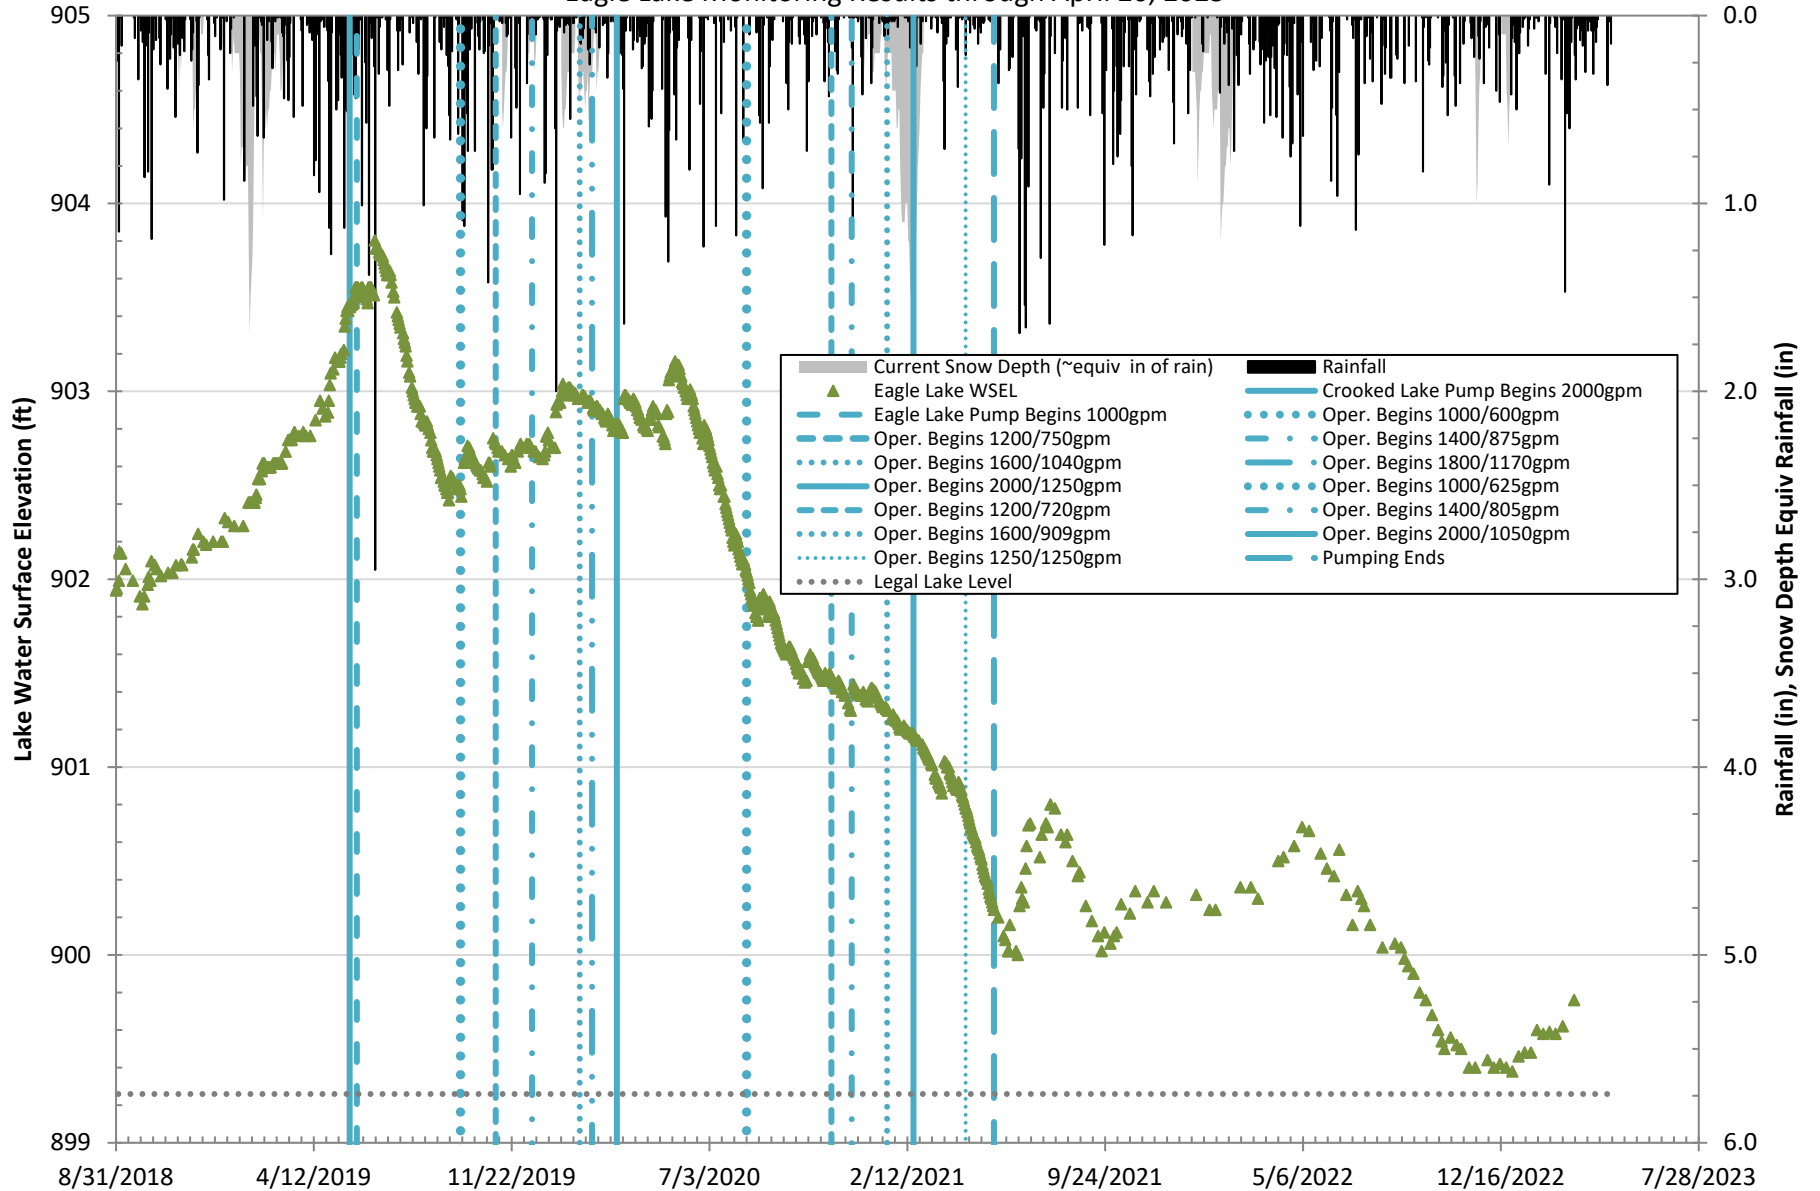
Figure

Eagle Lake Monitoring Results through April 20, 2023

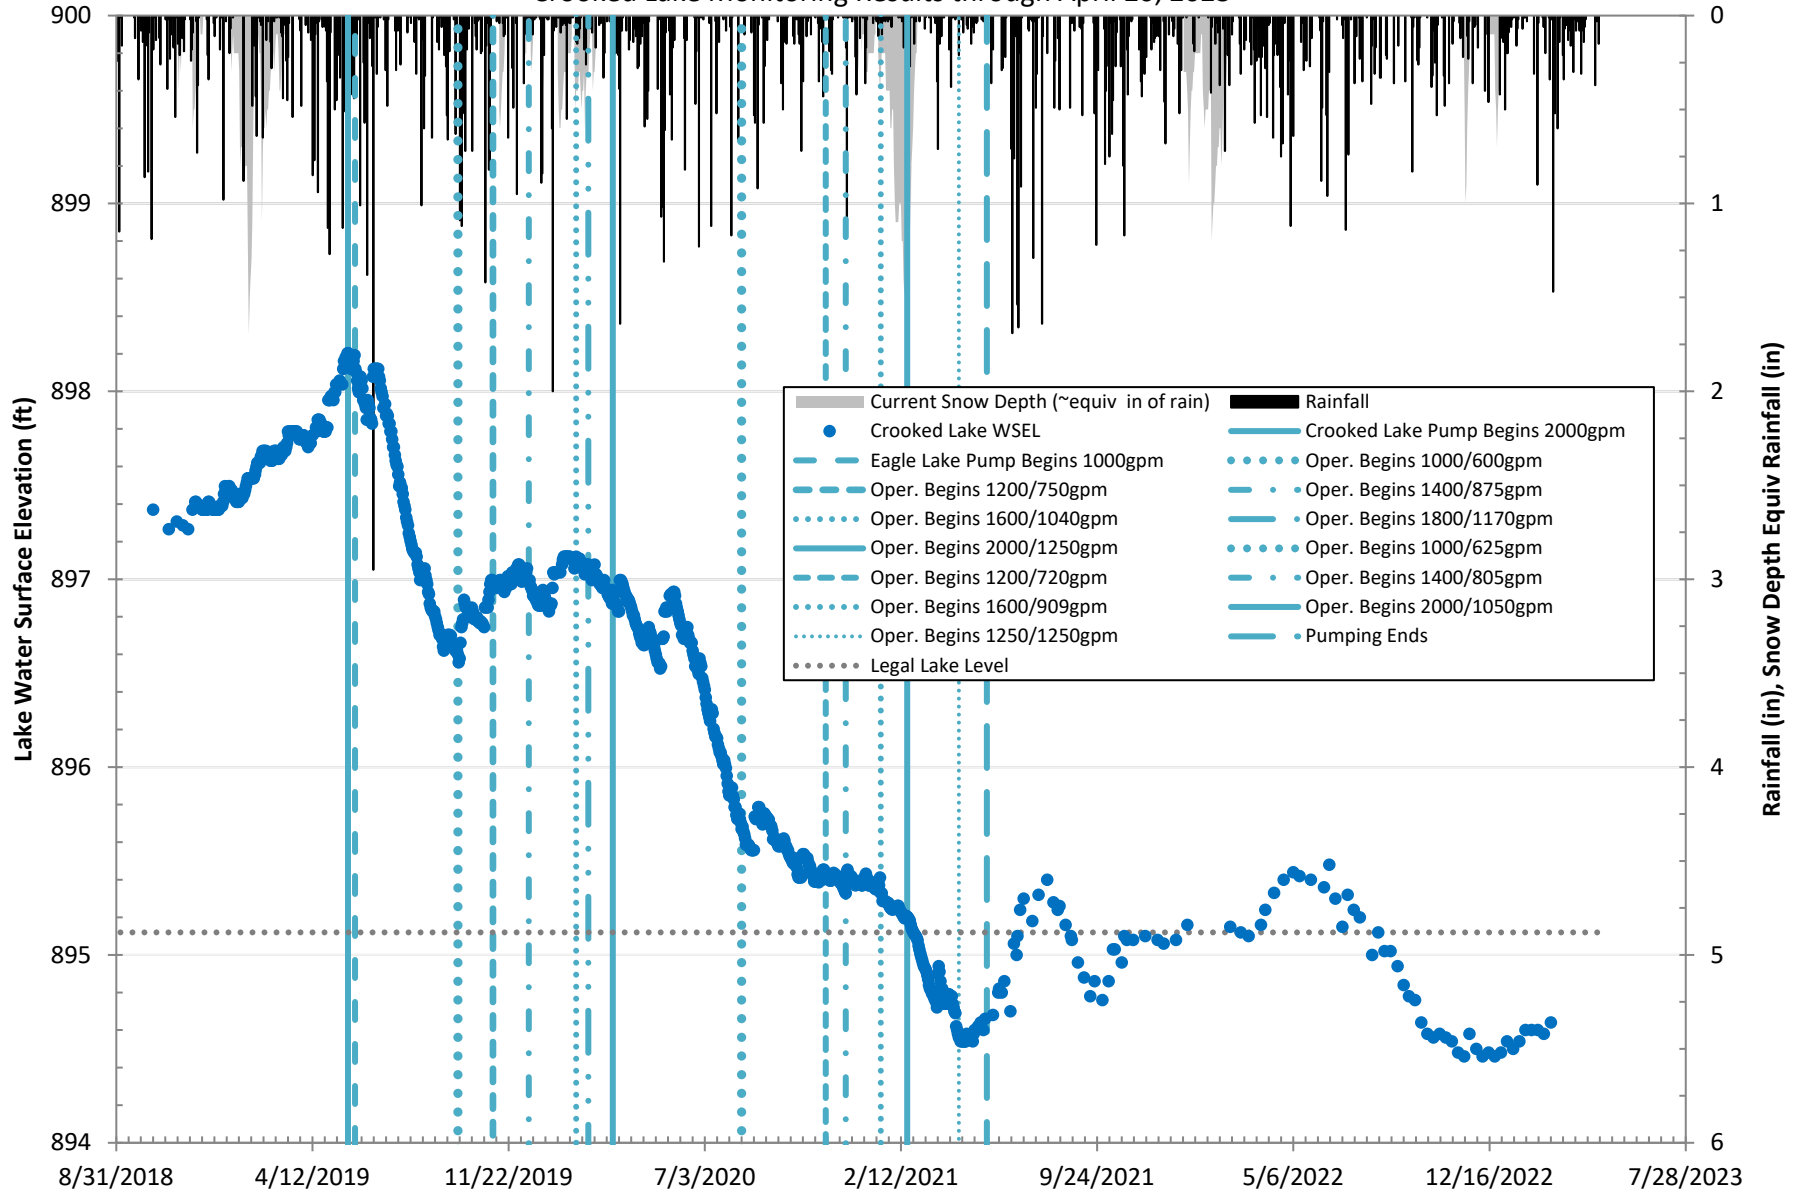
Figure

Crooked Lake Monitoring Results through April 20, 2023

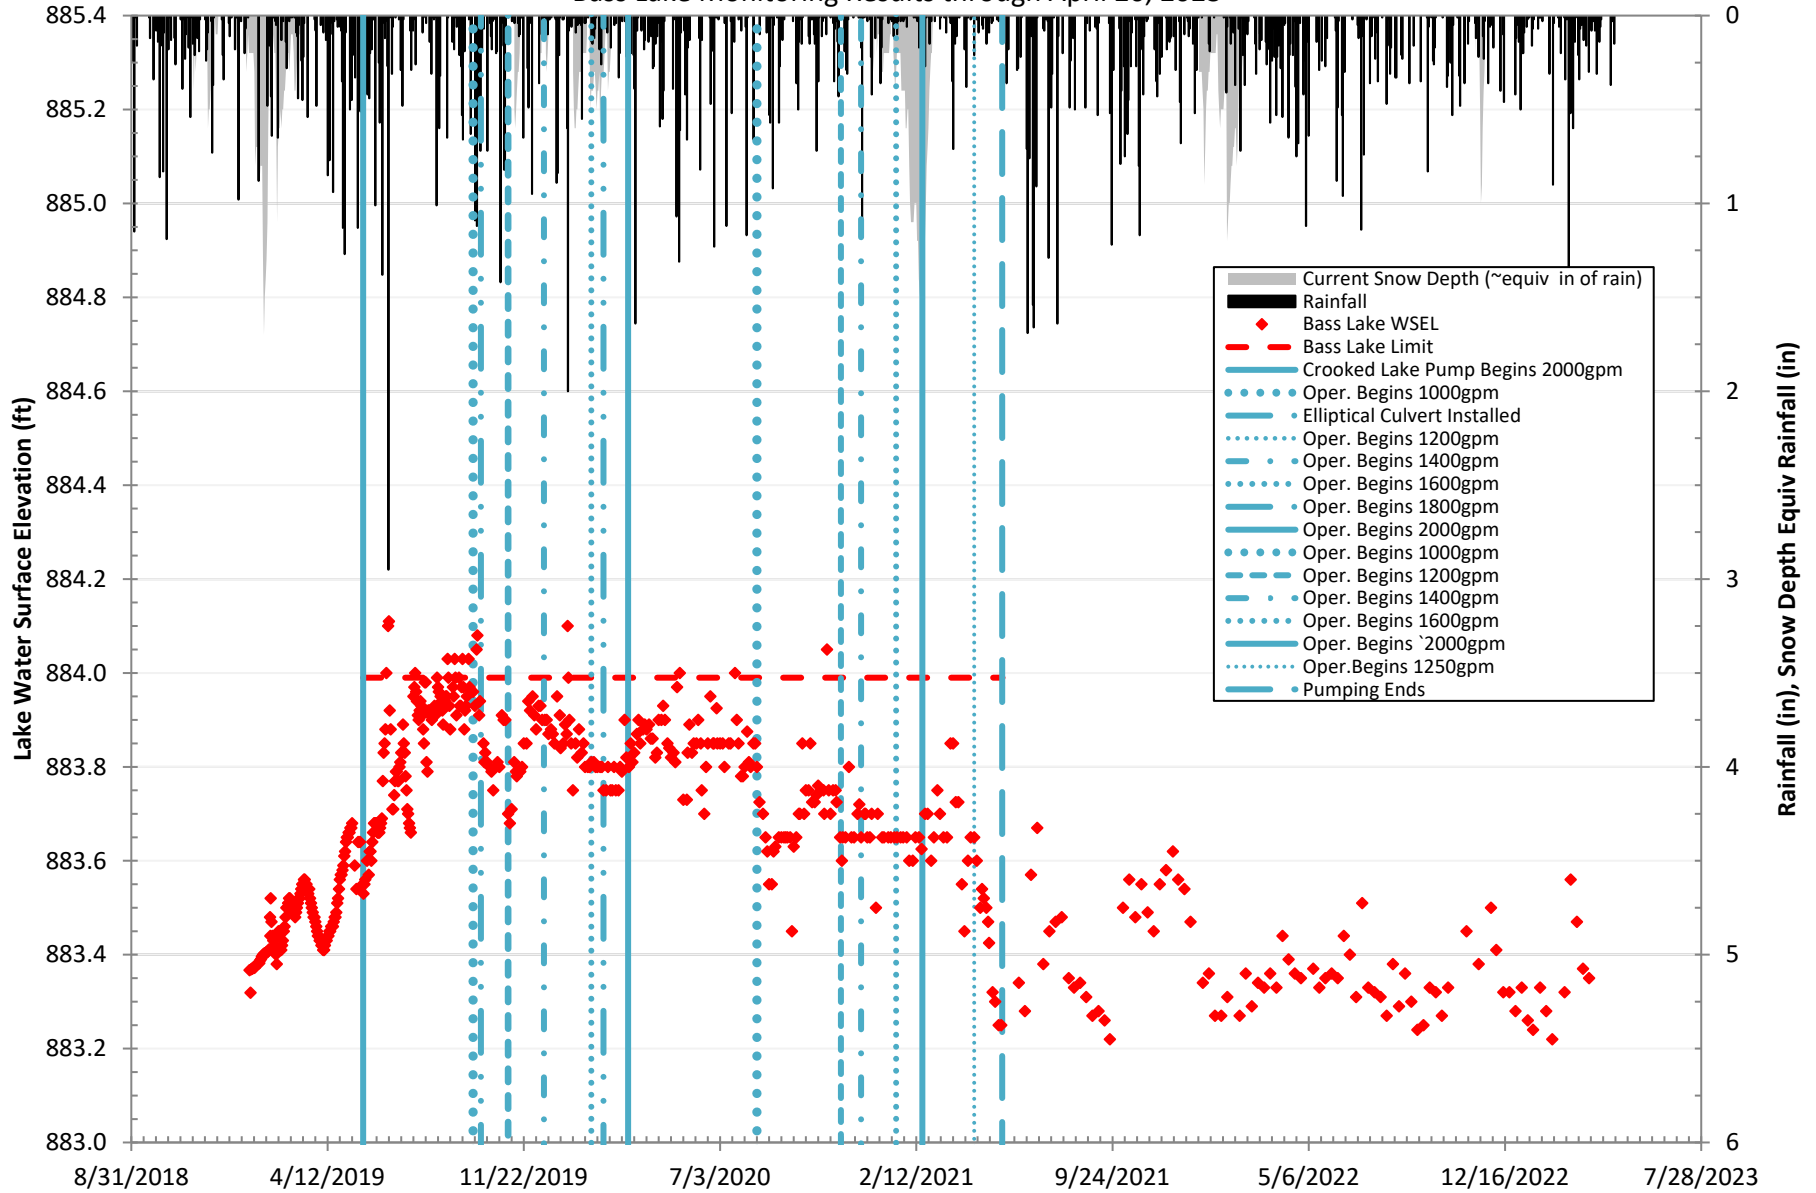
Figure

Bass Lake Monitoring Results through April 20, 2023

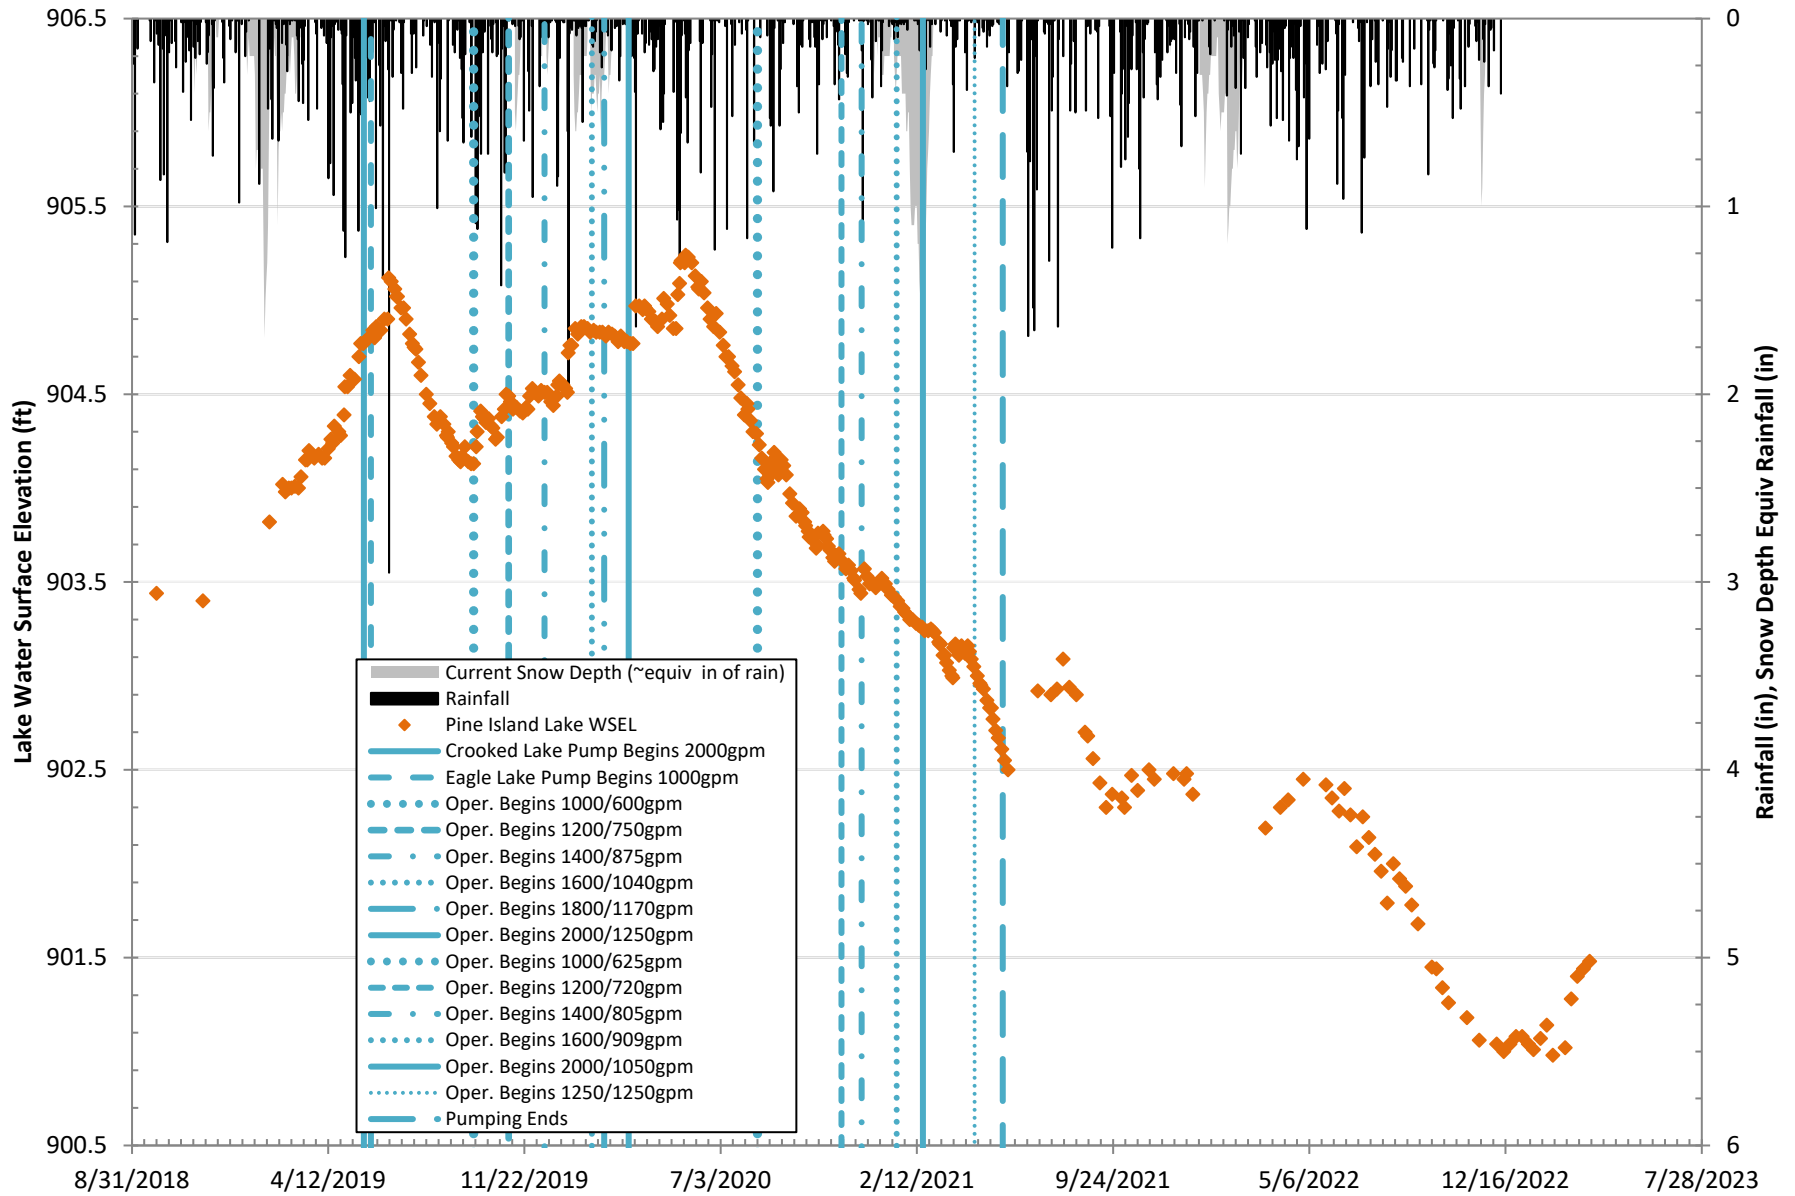
Charter Township of Texas Flood Study
 Figure
 Pine Island Lake Monitoring Results through April 20, 2023

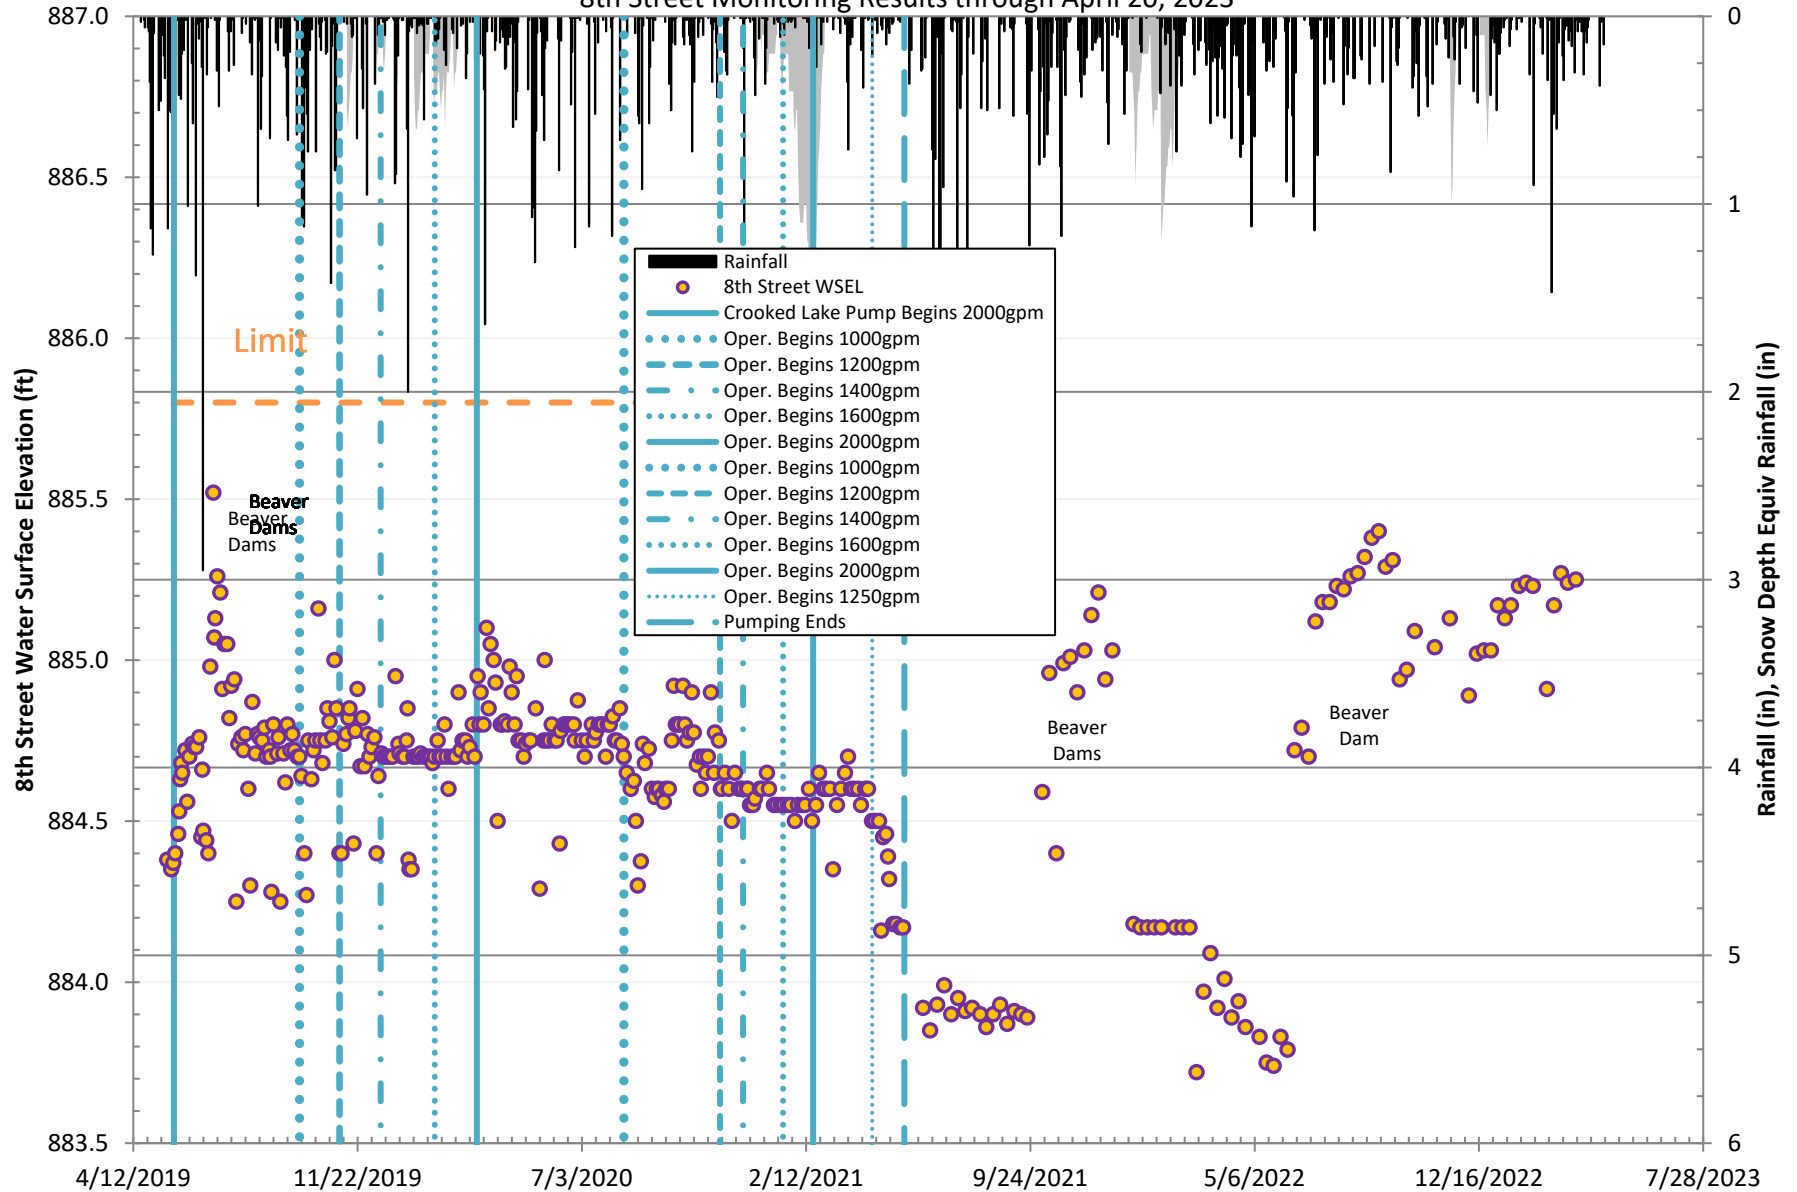
Figure

8th Street Monitoring Results through April 20, 2023

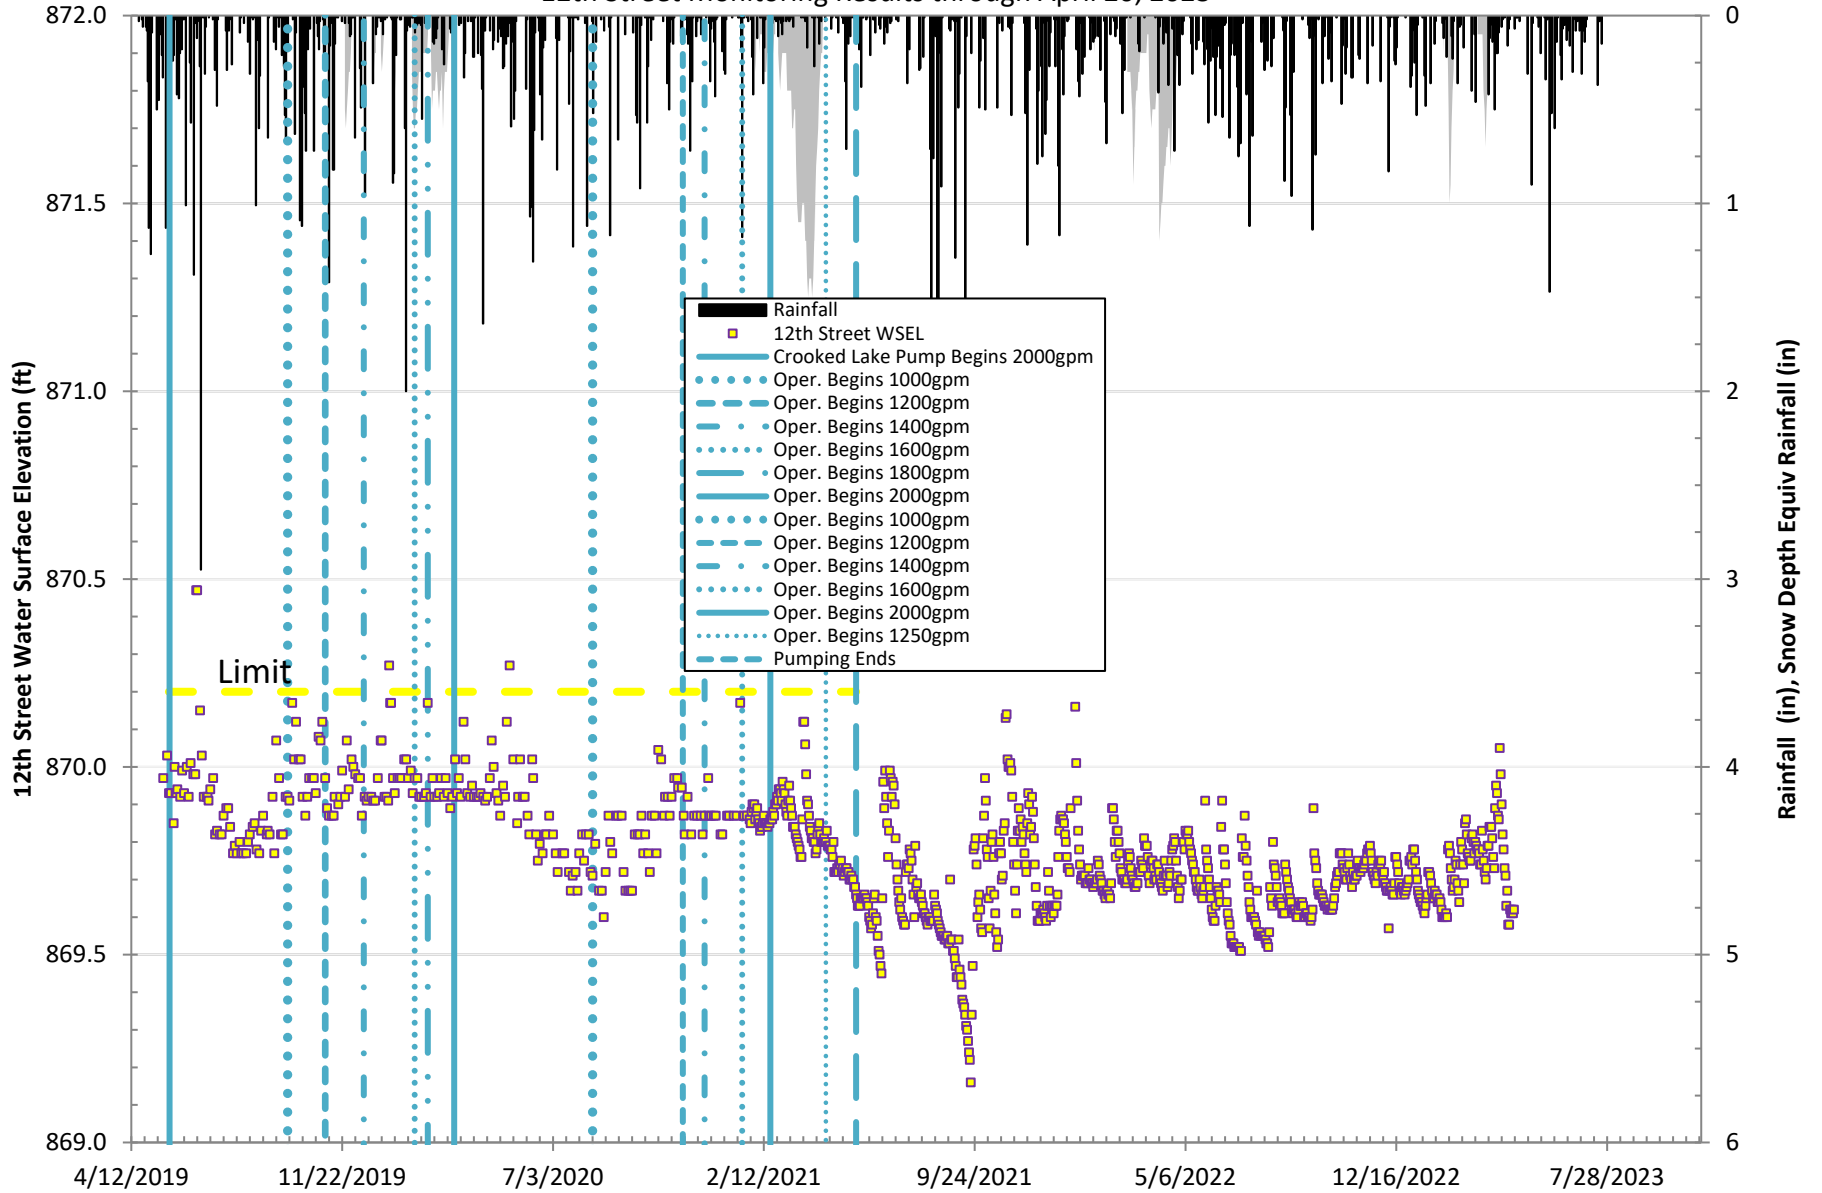
Figure

12th Street Monitoring Results through April 20, 2023

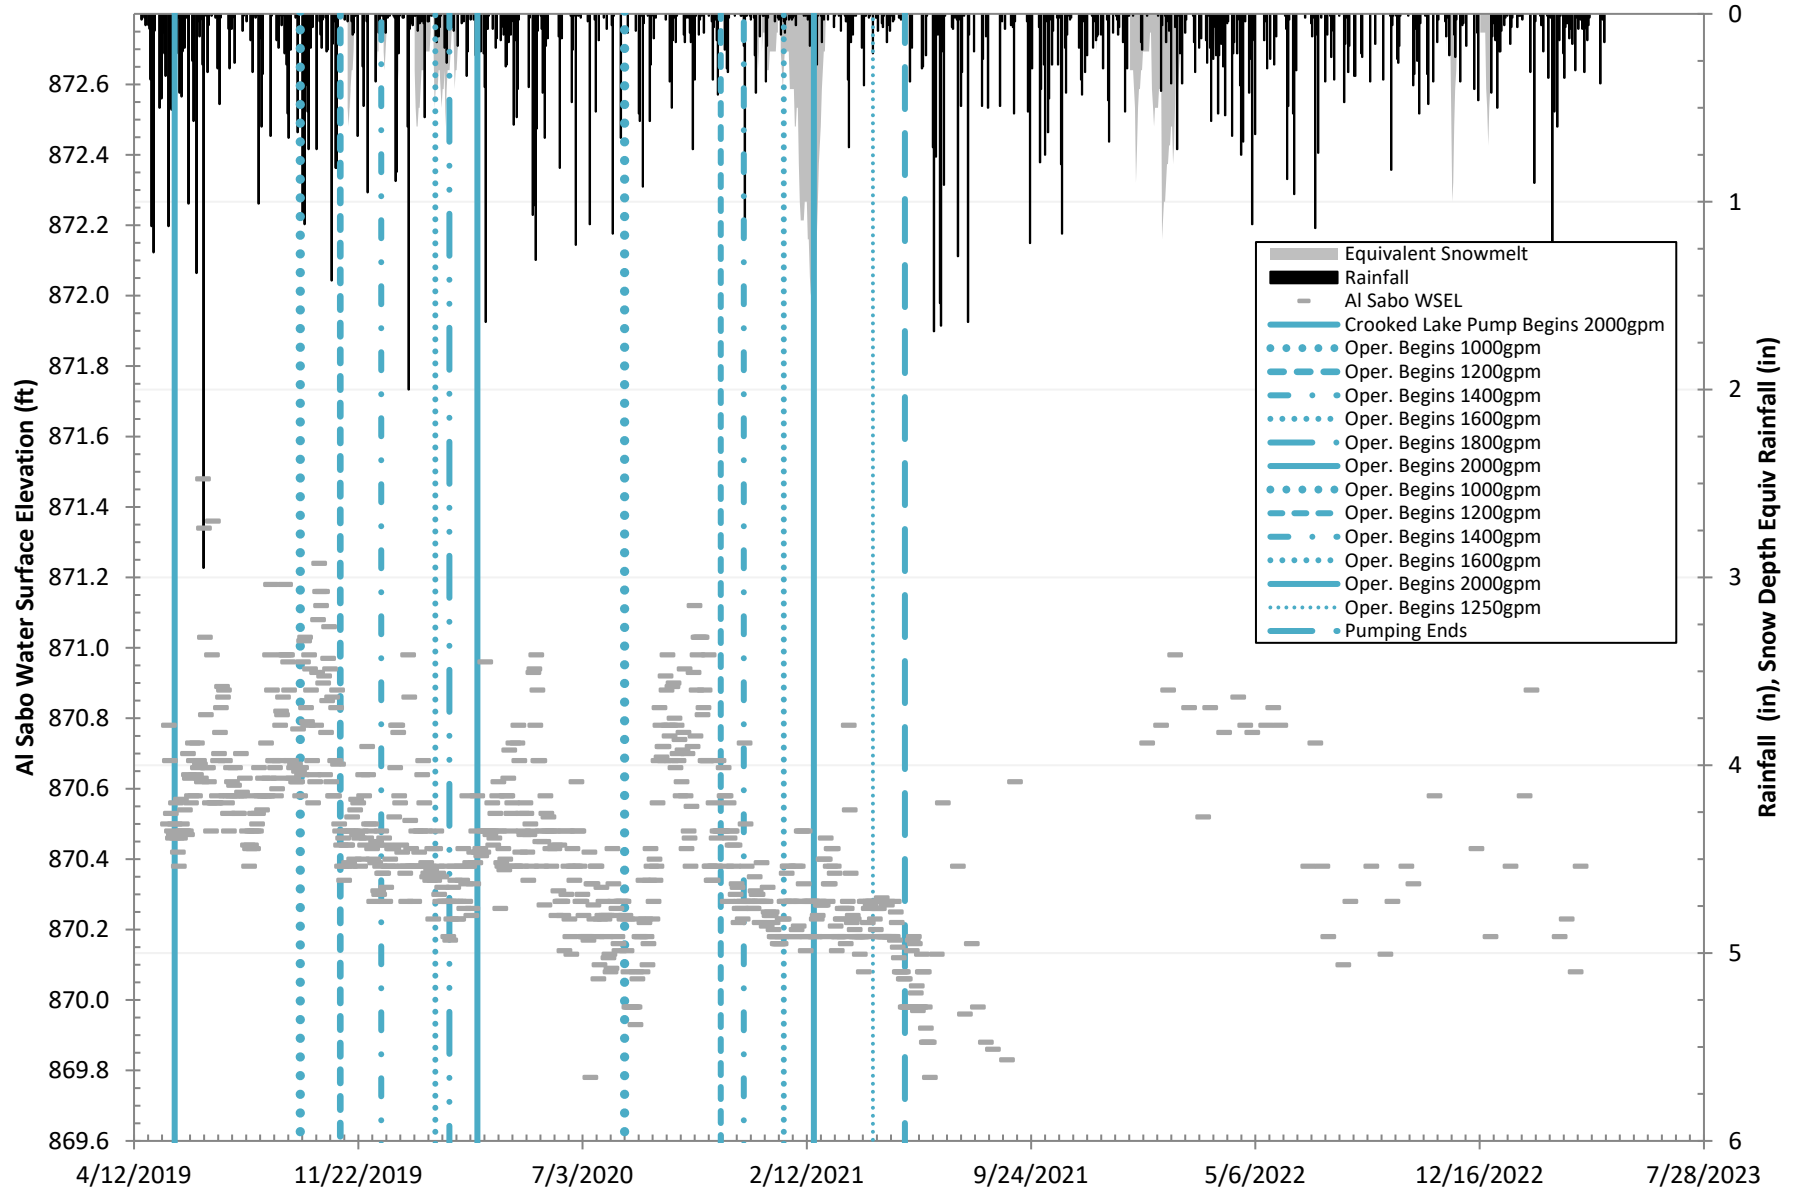
Charter Township of Texas Flood Study
 Figure
 Al Sabo Monitoring Results through April 20, 2023

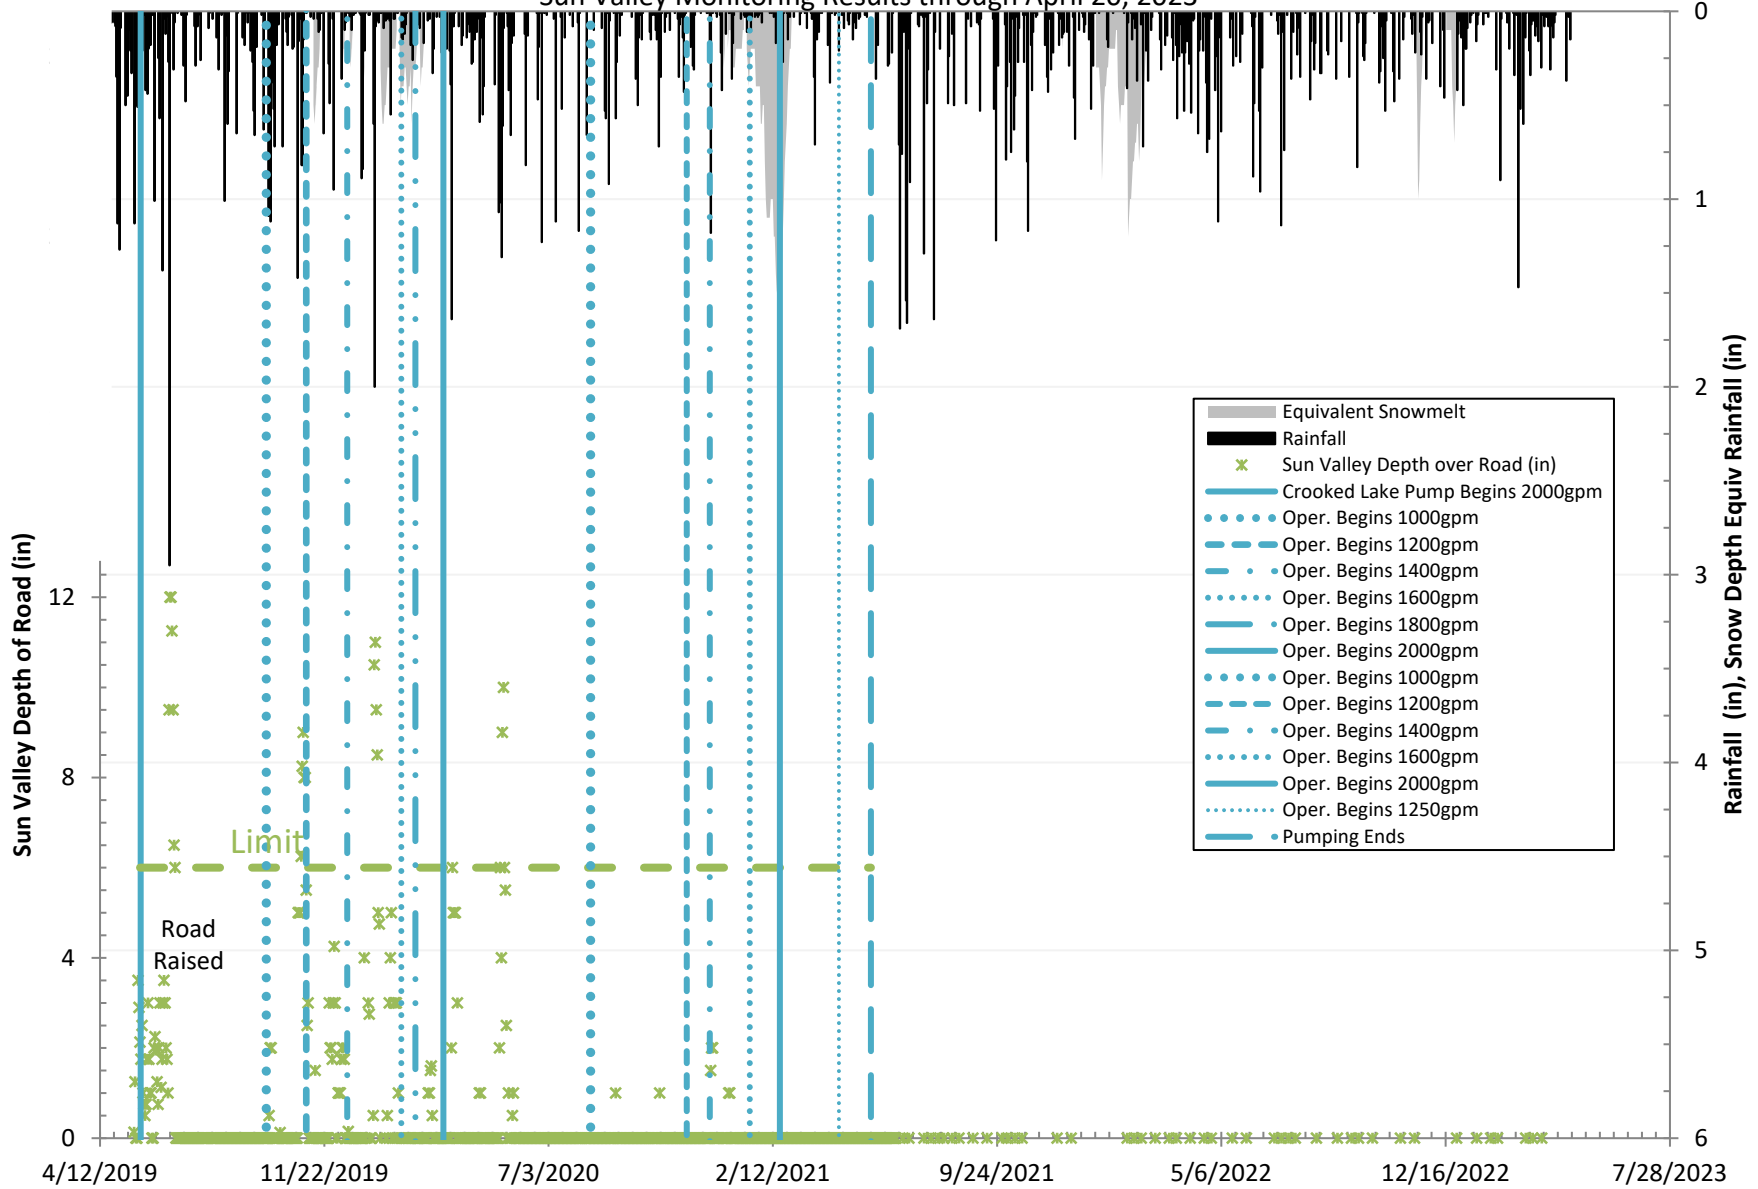
Figure

Sun Valley Monitoring Results through April 20, 2023

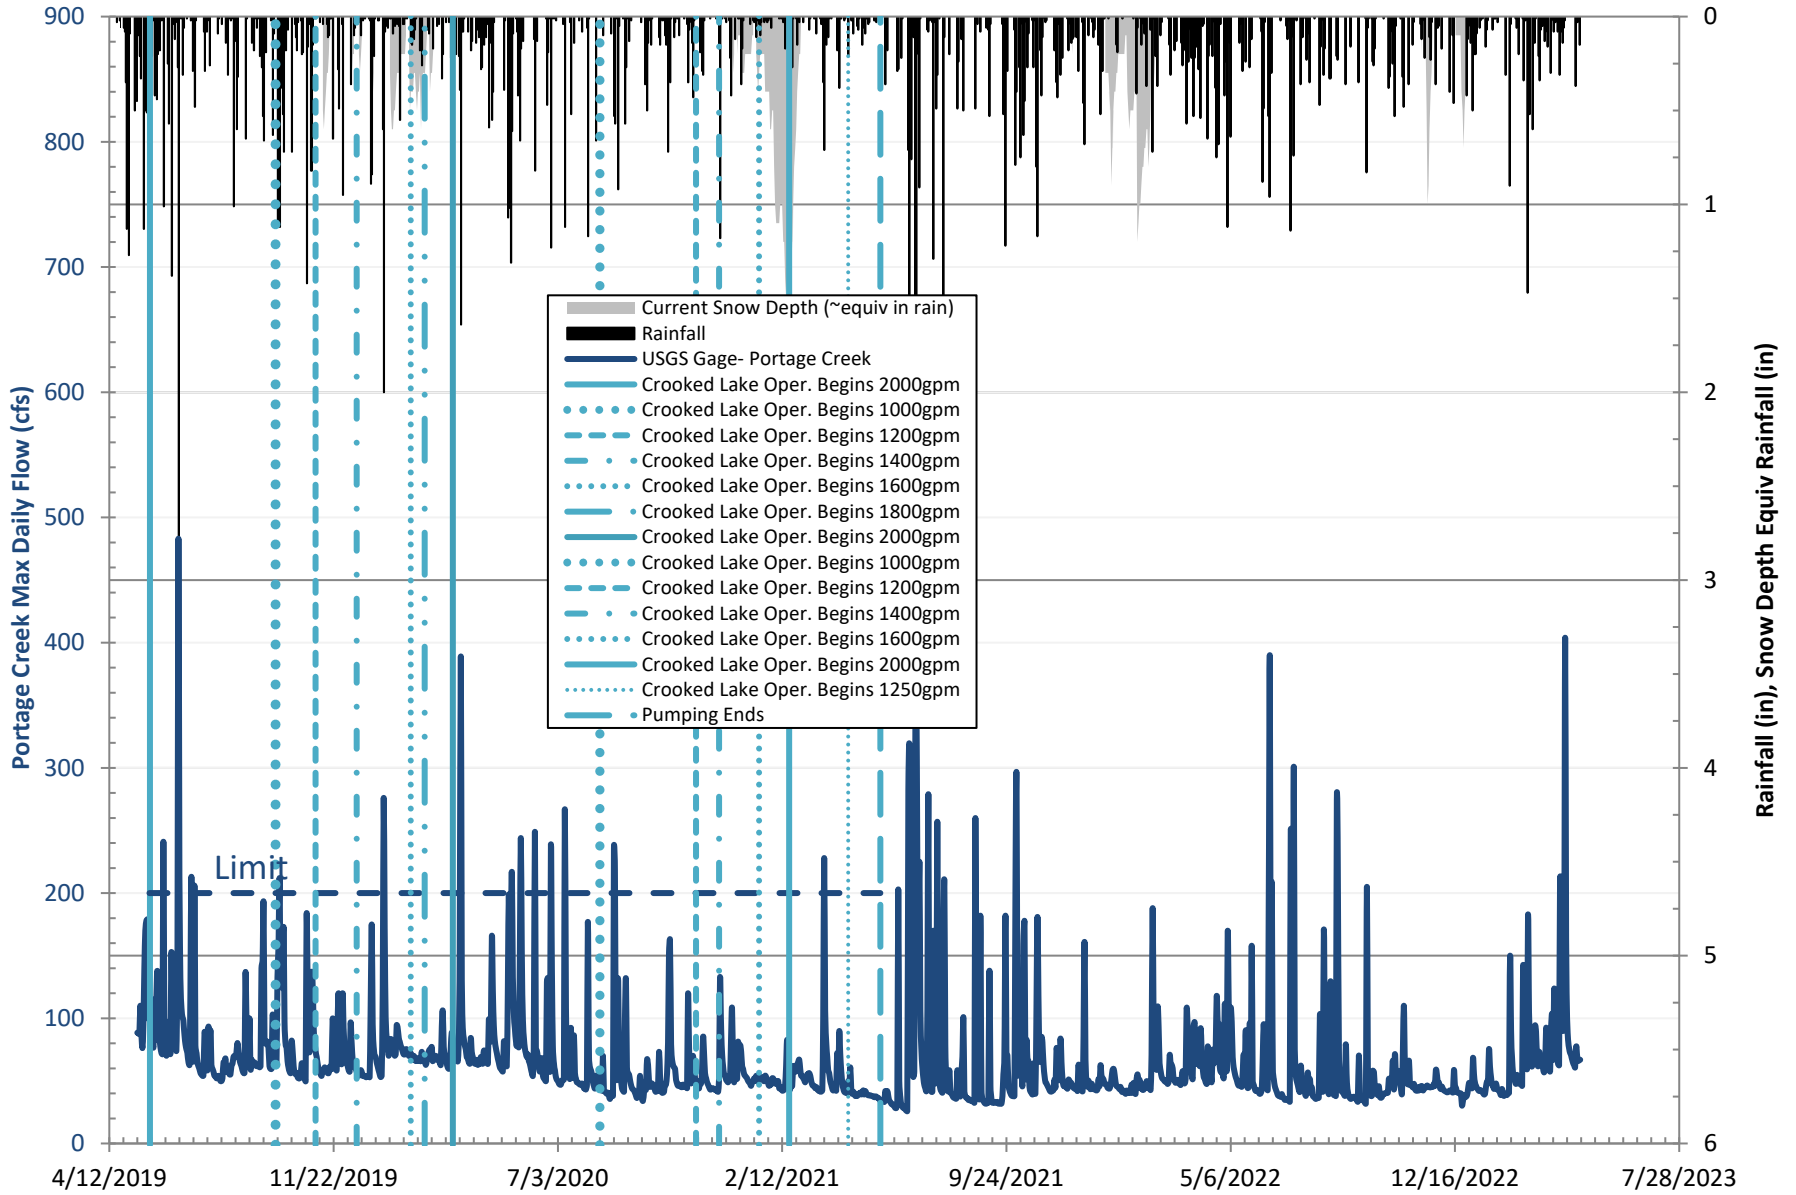
Charter Township of Texas Flood Study
 Figure
 USGS Portage Creek Monitoring Results through April 20, 2023

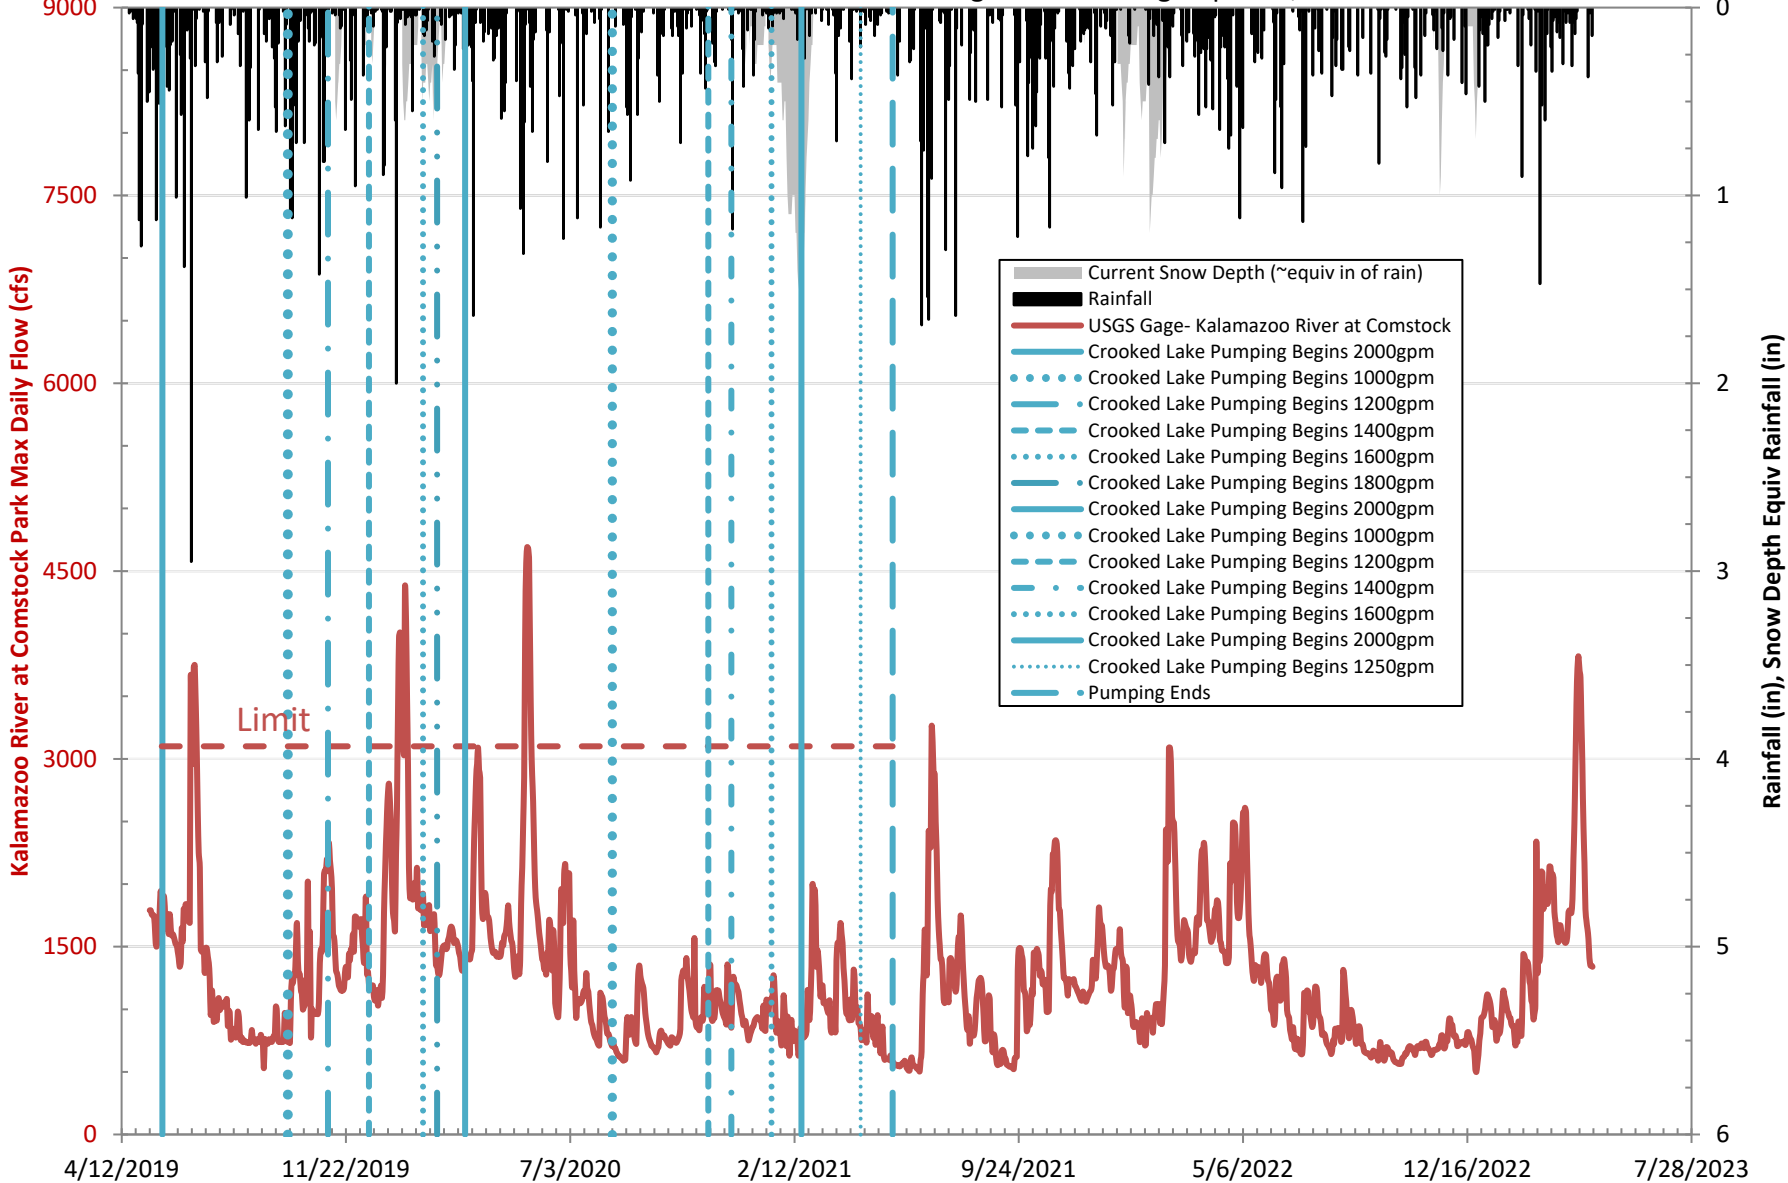
Figure

USGS Kalamzoo River at Comstock Park Monitoring Results through April 20, 2023
