Charter Township of Texas Flood Study

Texas Township Flood Mitigation

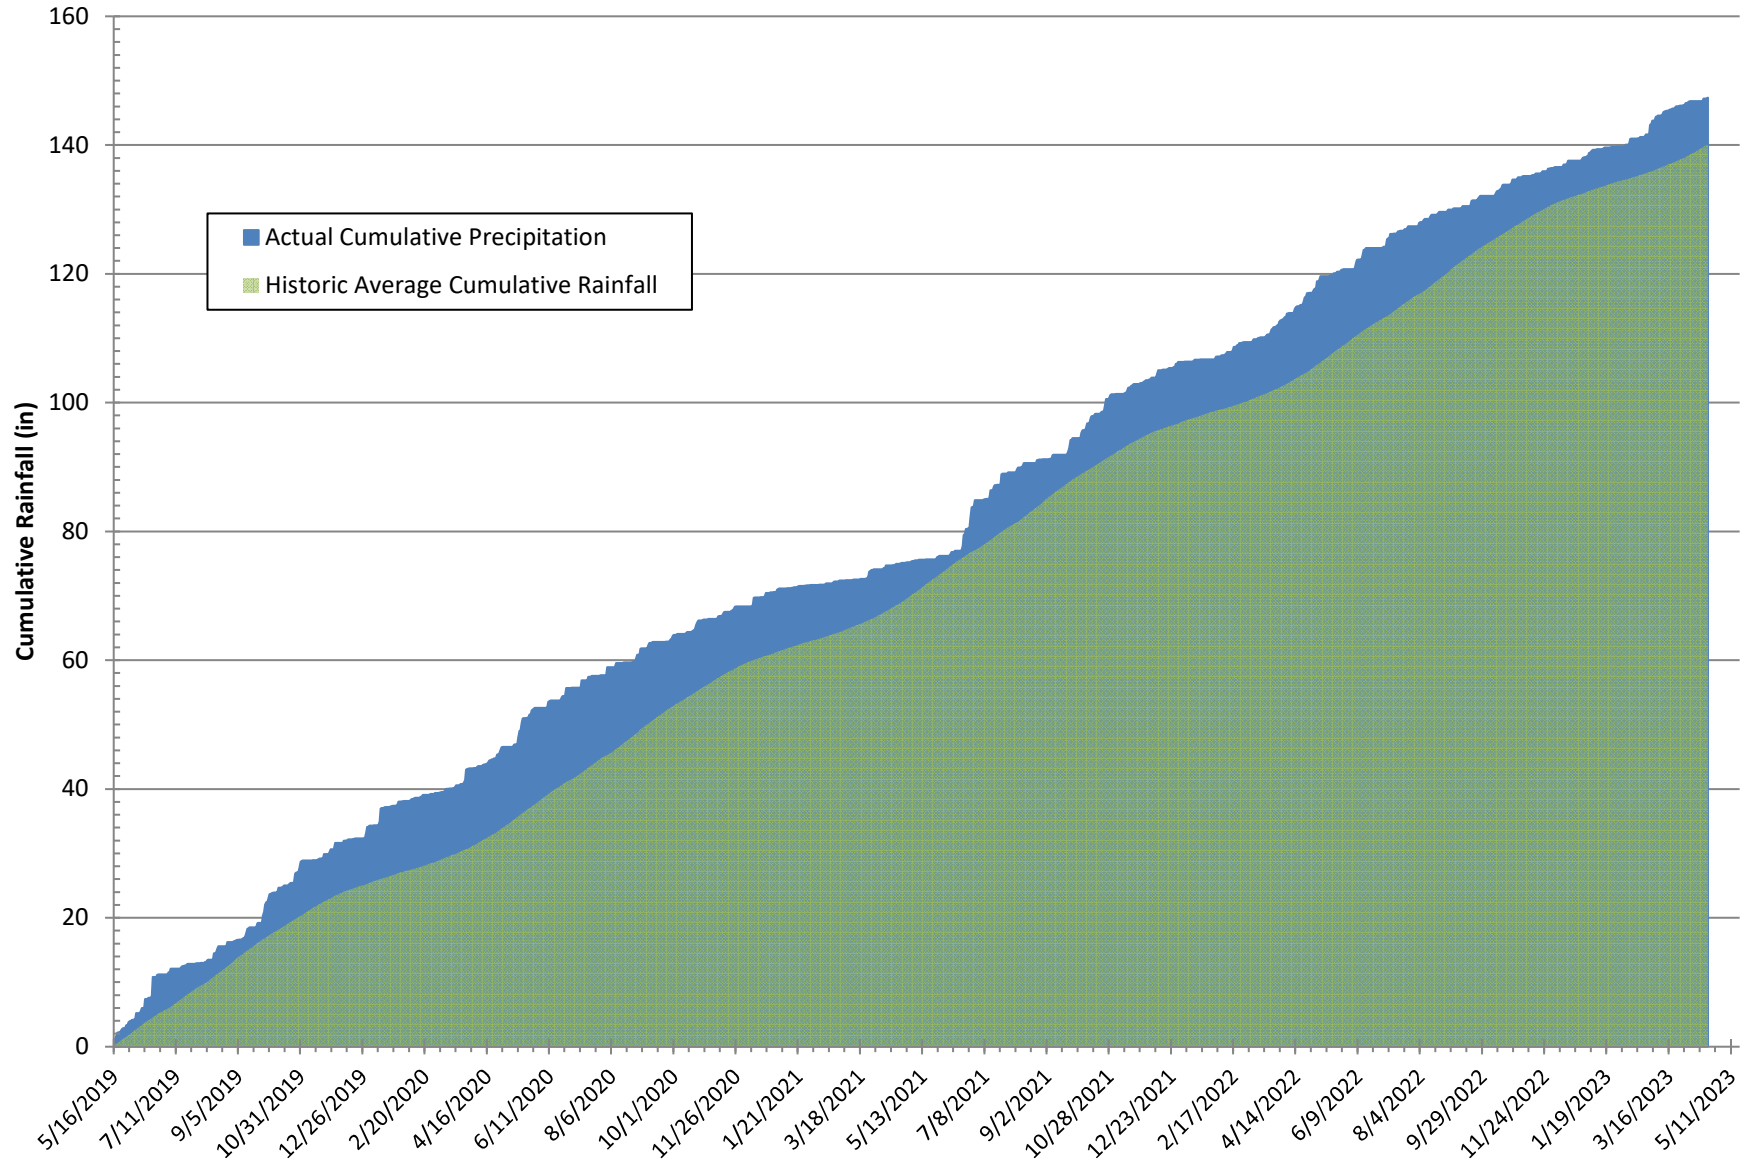
Average Rainfall vs Actual Rainfall from May 16, 2019 through April 20, 2023

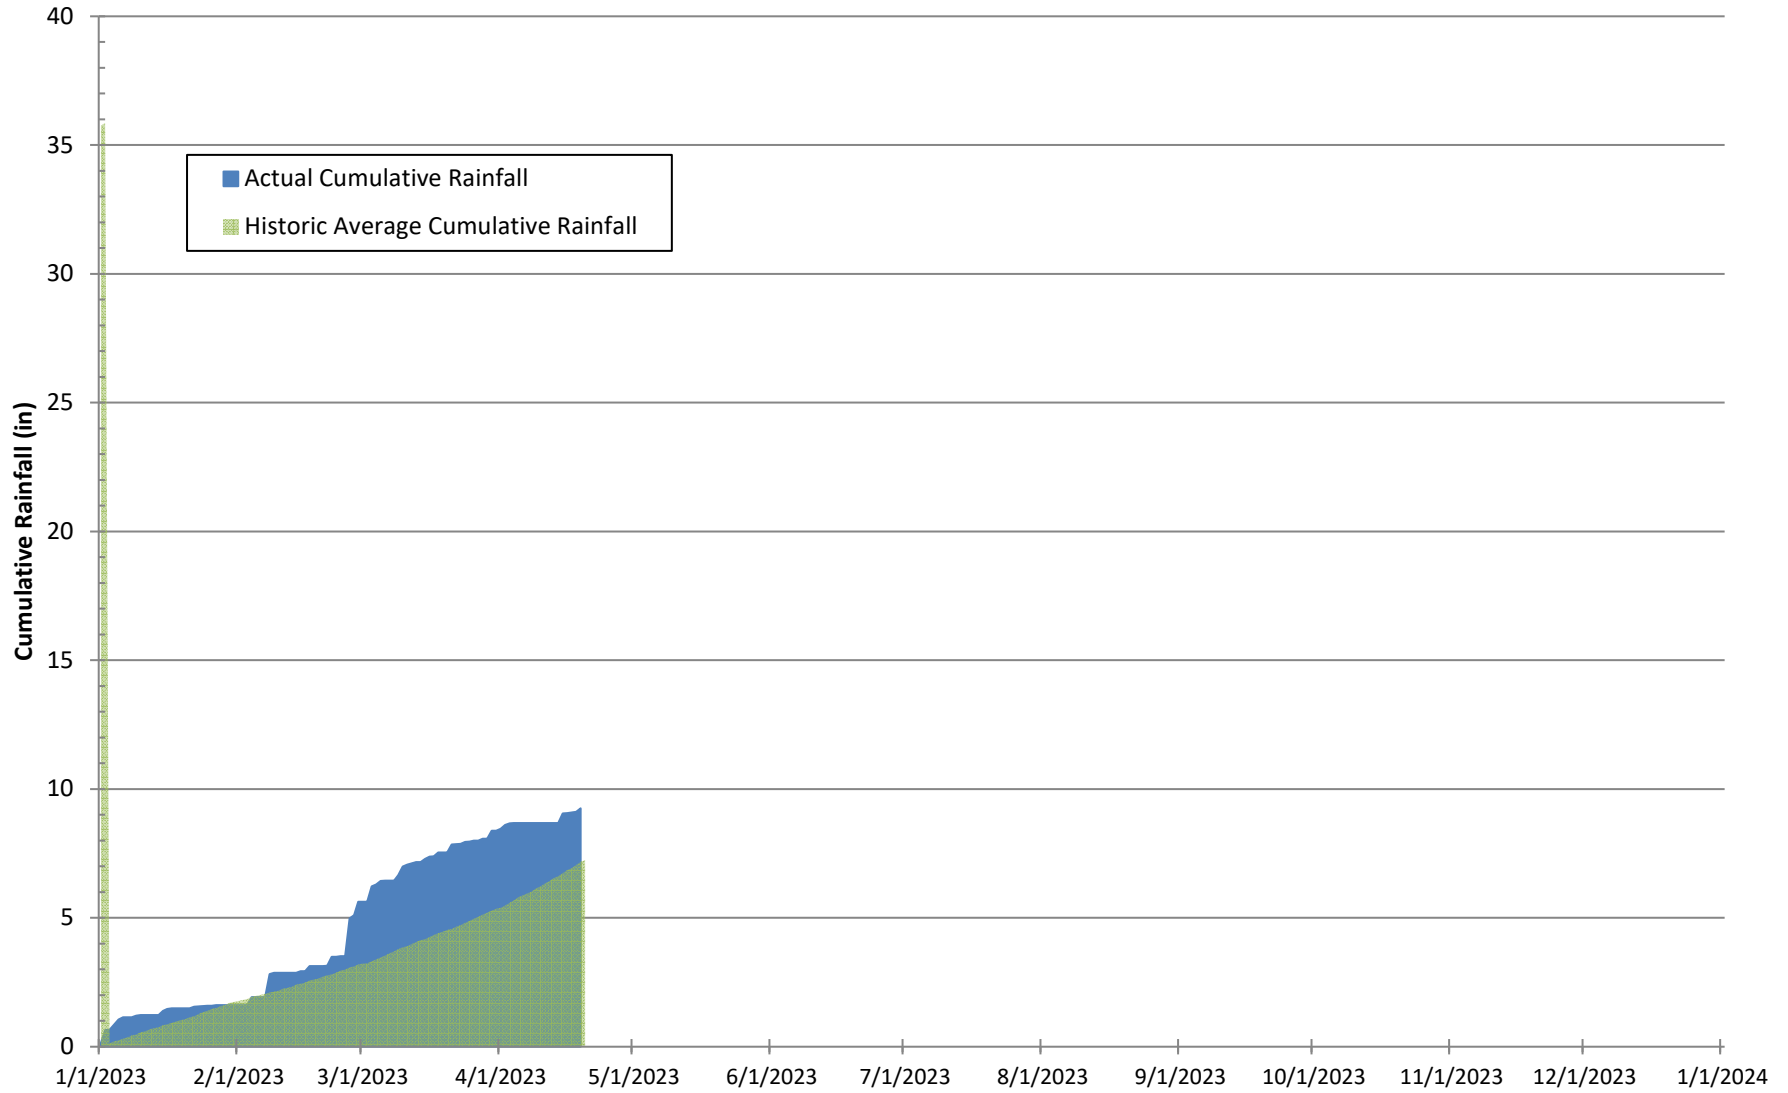
Average Rainfall vs Actual Rainfall - January 1, 2023 through April 20, 2023

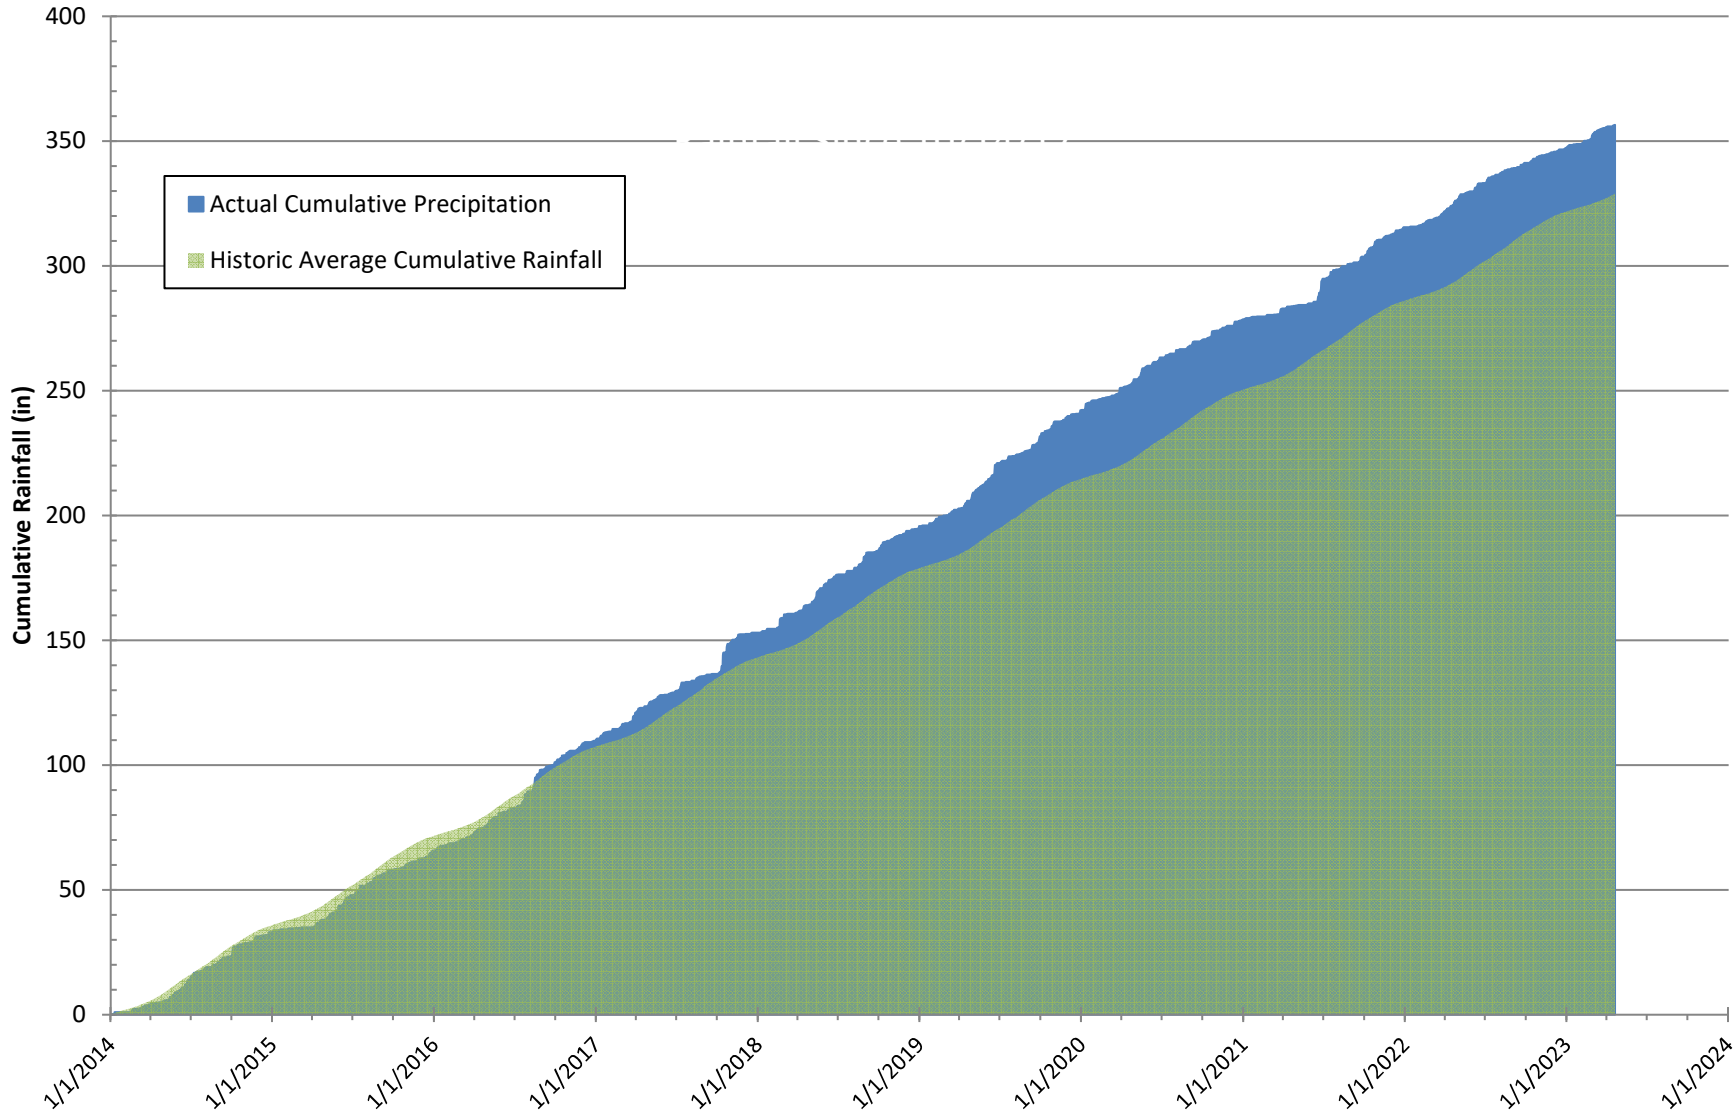
Average Rainfall vs Actual Rainfall - January 1, 2014 through April 20, 2023

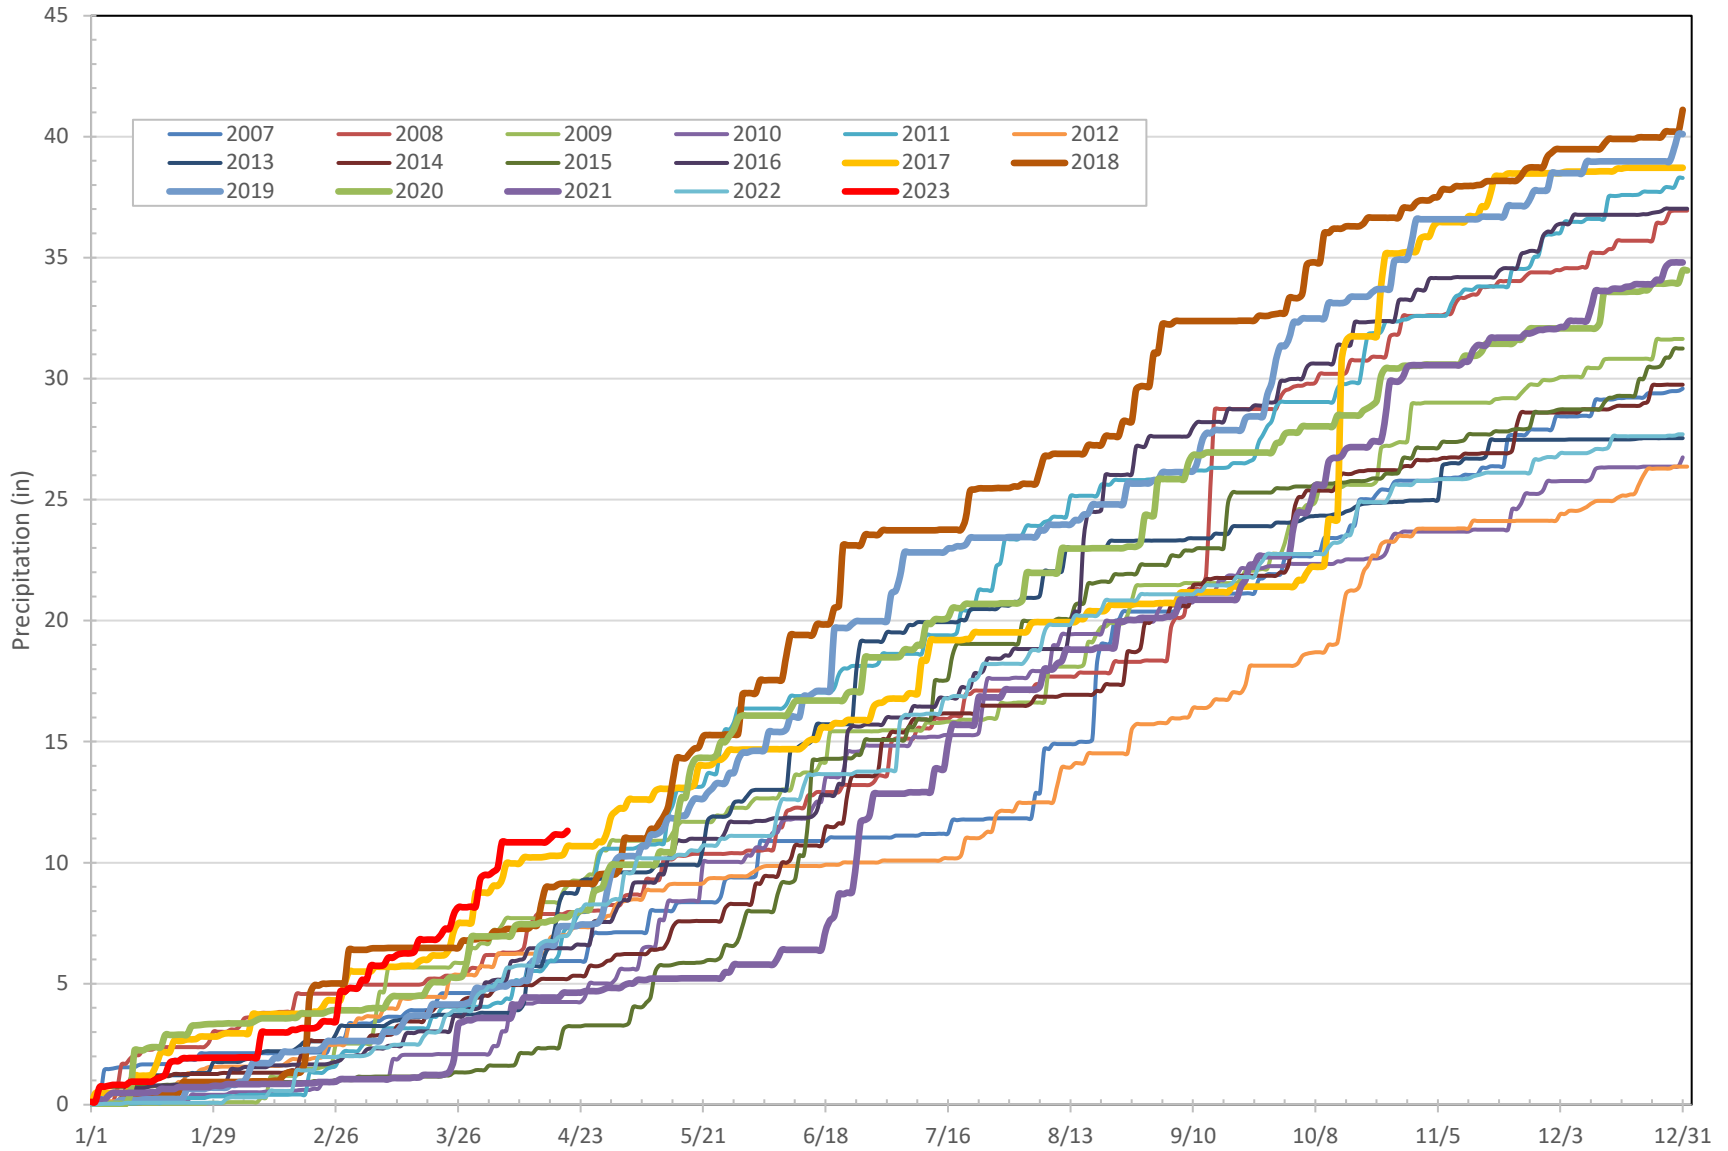
Charter Township of Texas Flood Study
Figure
Historic Cumulative Rainfall Data at Lawton, MI through April 20, 2023

Source: Enviro-weather

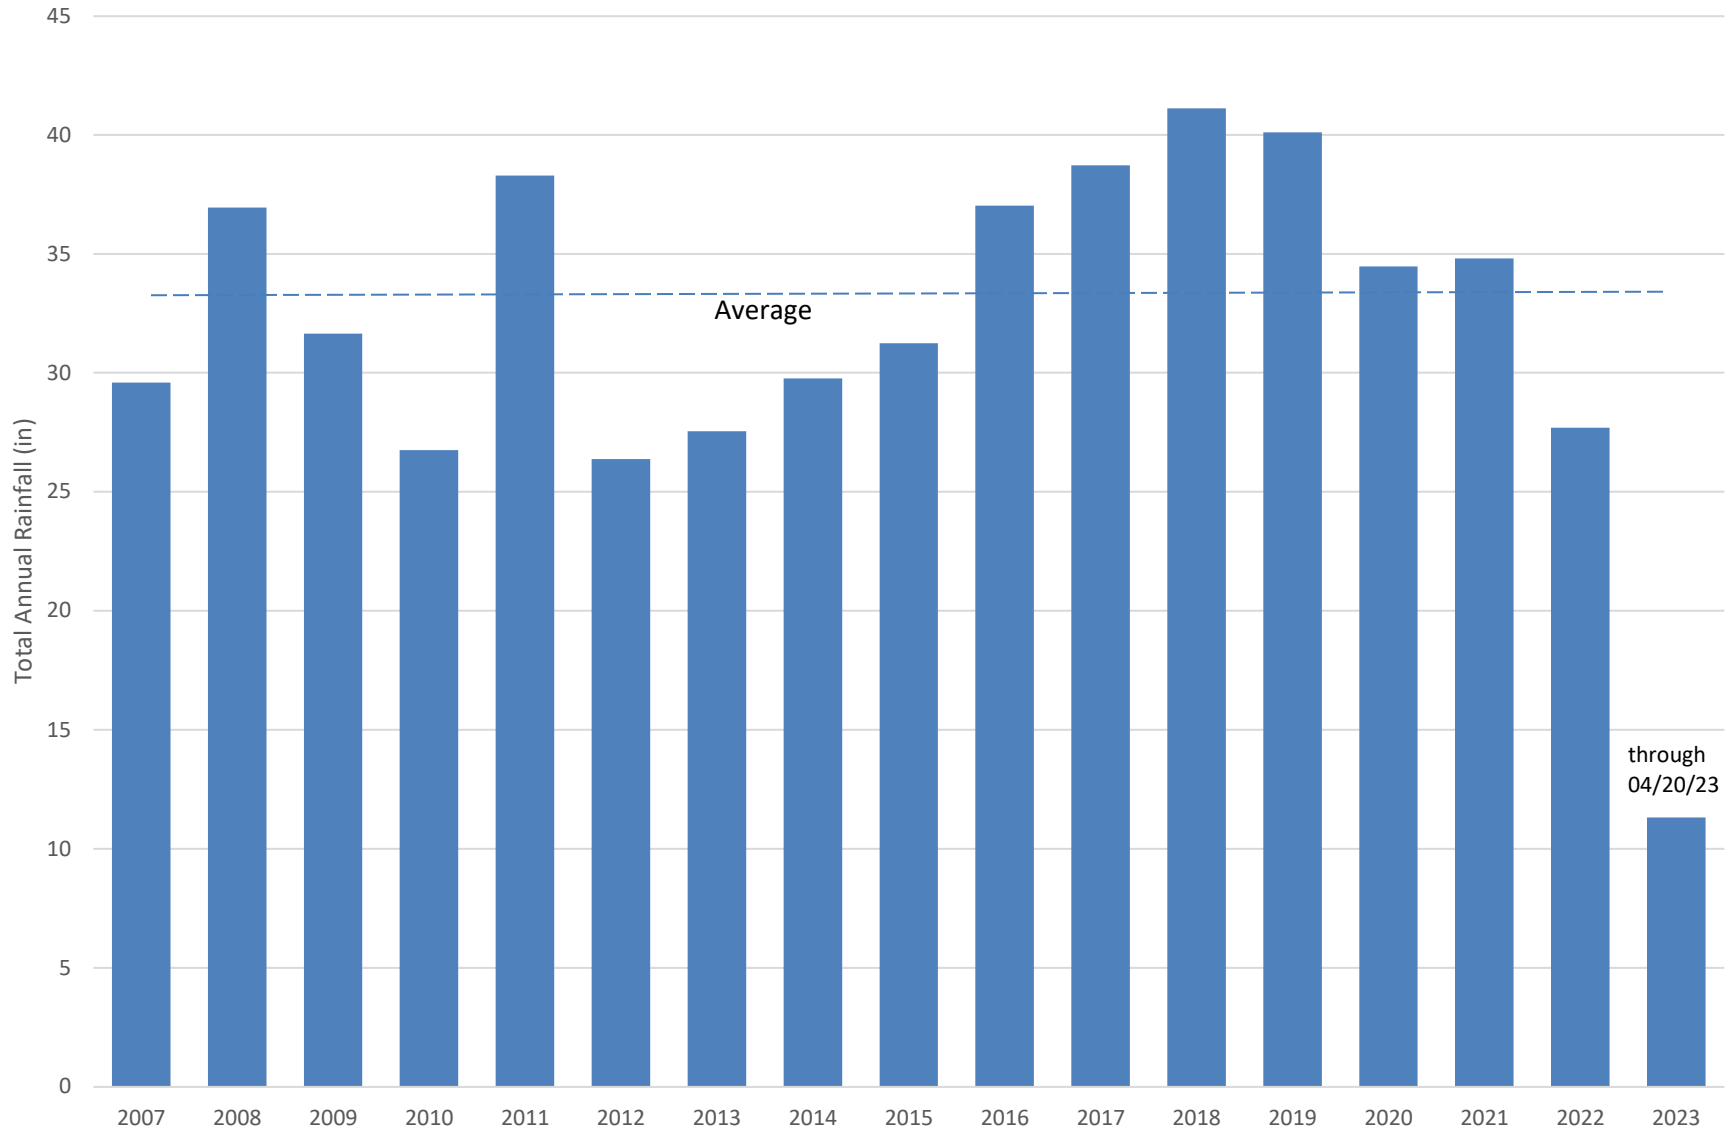
Figure
Historic Rainfall Data

Historical Annual Rainfall in Lawton, MI

Source: Enviro-weather
